Property Condition Report

ST. CATHERINE OF SIENA PARISH CENTER AND CHURCH

302 St. Catherine's Circle
Ithaca, New York

October 31, 2007

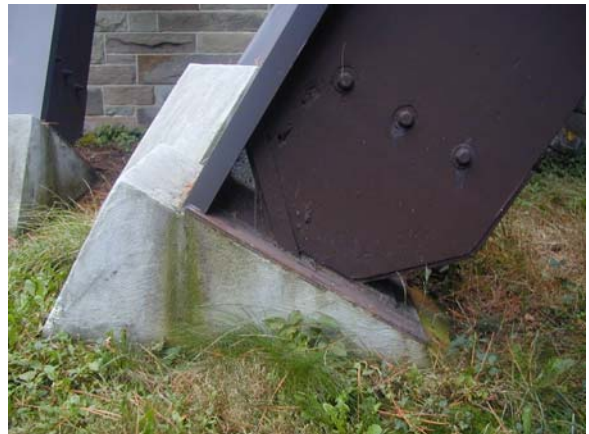
Beam bases.

The church roof structure consists of a deck of 3x6 tongue-and-groove spruce planking spanning between A-frames of large, exposed glue-laminated rafter beams. Fourteen A-frames support the gables of the four wings, and two support the valleys. The bases of the beams feature beveled upper and lower corners, and are connected to the concrete piers through steel saddles shaped to their beveled profile.

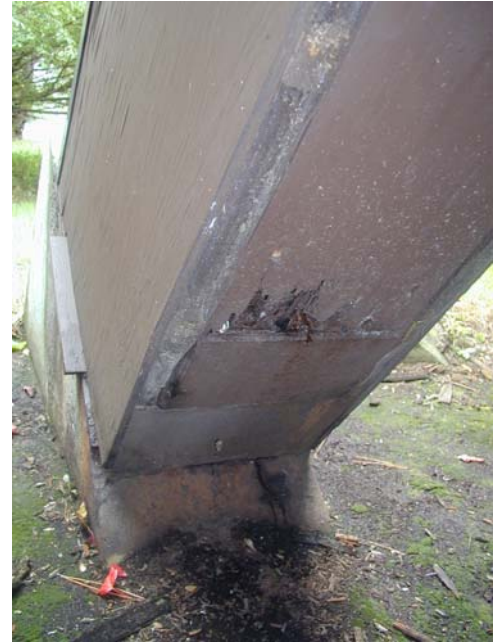
At the bottoms of the valley frames, large voids marking a history of moisture-related decay are visible to an extent not seen in the gable frames. This is probably a result of their historical exposure to large amounts of runoff funneled down their

tops by the valleys above them. Steel saddle extensions have been installed on the valley piers as corrective measures to make up for the loss of wood structure at these locations. The conditions appear stable, but should be checked regularly for changes.

Decay at valley rafter bases and structural reinforcement.

To prevent further moisture damage, the top face of every beam has been retrofitted with a sheet metal cap from eave to pier, and the resultant joint between pier and cap treated with sealant. The valley frames have been further protected by the addition of a sheet of plywood on each side. The additions of these items created semi-concealed spaces that have been protected by screening to prevent insects or small animals from moving in.

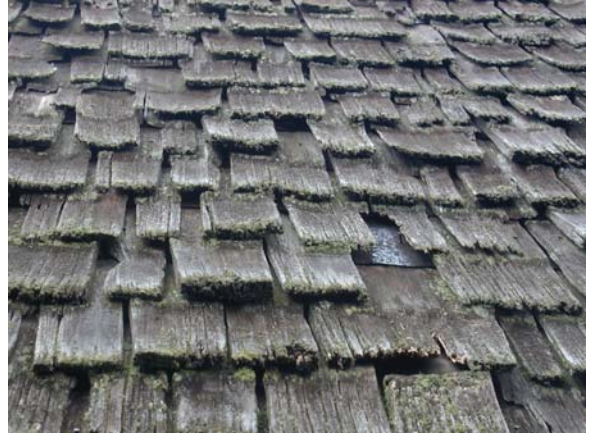
The shakes, however, are overgrown with moss, several are curling, and a few are missing. At about forty-six years old, they are at the end of their service life. The Consultant Team recommends short-term replacement.

Closeup of church cedar shakes.

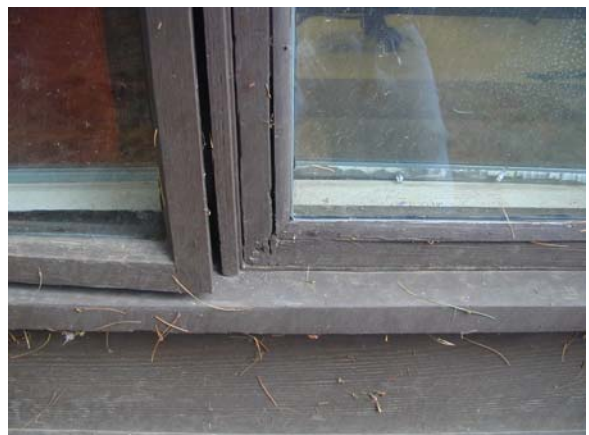
Sash detail of west facadecasement showing aging and repair.

Windows are generally in good, operable condition, with exception of casements on the west façade of the assembly wing. Windows there have been subject to weathering and a few sashes have been replaced.

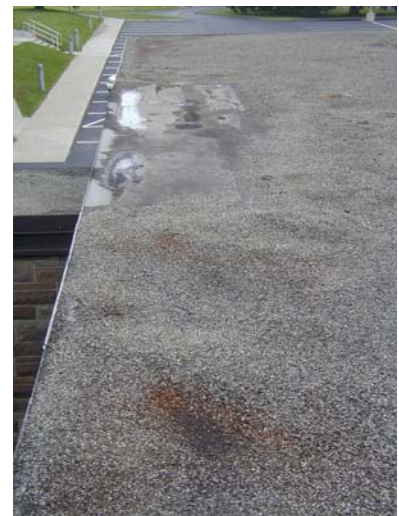
The roofs are essentially flat, although there visually appear to be high points in the centers of each of the largest roofs. Cants at the perimeter edges provide sloped drainage away from the roof edges toward the drains. Perimeter drains are located on each roof, near the perimeter edges and at the base of the cants. There visually appears to be a high point in the center of each main roof, which might be a result of a camber in the roof framing members. Although the roof was nearly dry at the time of the survey, some ponding was described by the Owner's representative to occur over a section of the center wing, near the connecting link to the east wing.

Ponding at roof edges.

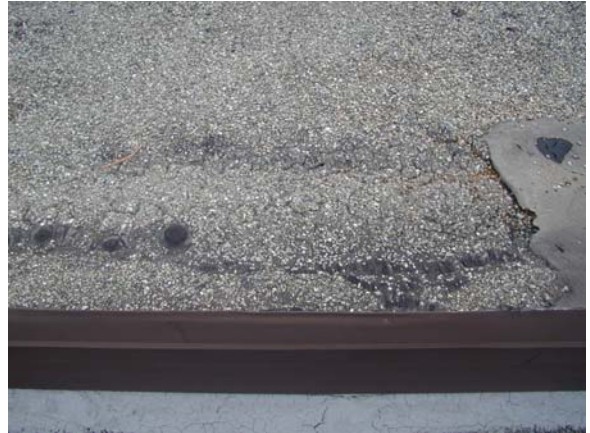
The roofs are in poor condition. Leaks have occurred repeatedly over all areas except the assembly wing roof. The membrane has blisters in many areas indicating probable moisture in the system. Metal roof edges have come off in some areas. Membrane flashings terminate roofing at vertical surfaces, redwood fascias and windows. Flashings are coated and show signs of failure such as alligatoring and tearing.

Blistering and patching near roof edges.

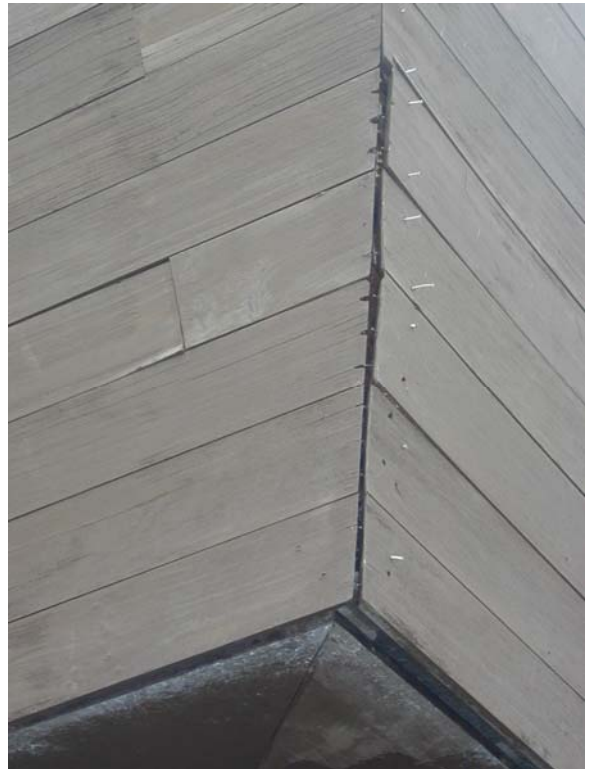
At many locations around the building, and particularly at the corners, nails have backed out of the fascia boards as a result of movement.

Opening miter joints and nail pops at fascia corner.

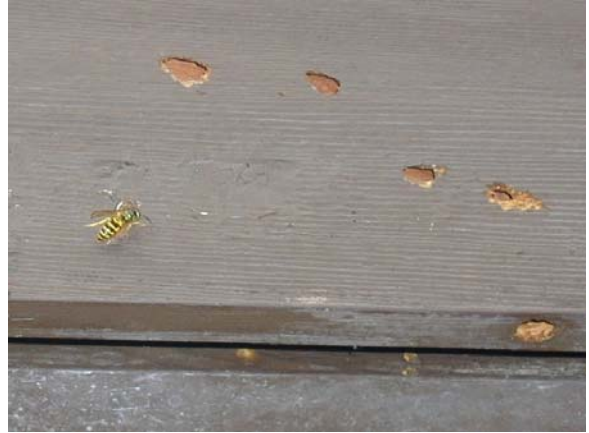
Fascias on the south side of the building show signs of possible insect damage and bees were seen entering the small holes.

Bee.

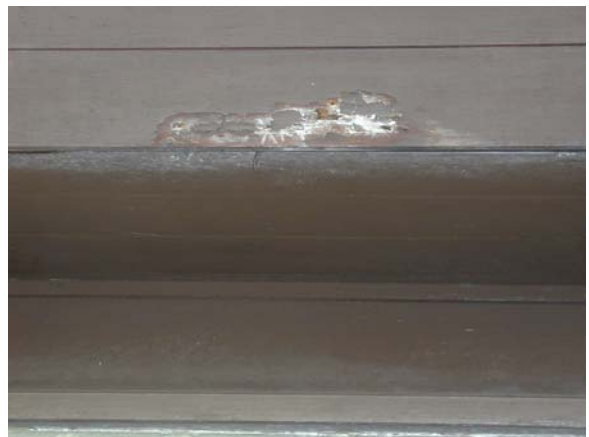
One small area of wood, somewhat close to the area of roof leaks, is rotted. Further investigation is needed to ascertain extent of rot present and whether or not other system components are affected, including framing.

Rot.

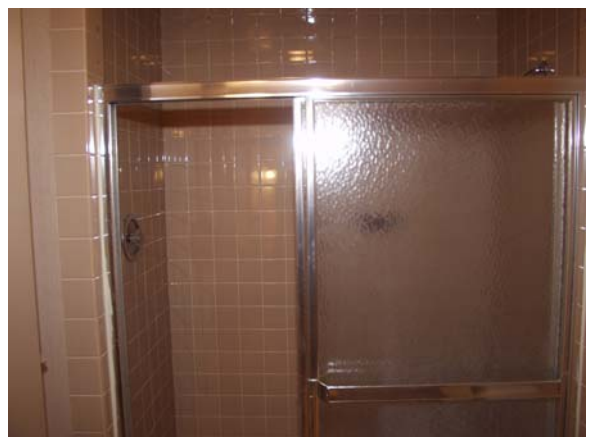
This shower is no longer used, wasting space and making reorganization of Section 1 difficult.

A better solution might be to provide two larger bathrooms to serve both Sections 1 and 2. These could be located either in the existing garage space, or in Section 2. If the bathrooms can be removed, the East office spaces might be improved substantially by a larger space with windows and a view of the interior garden.

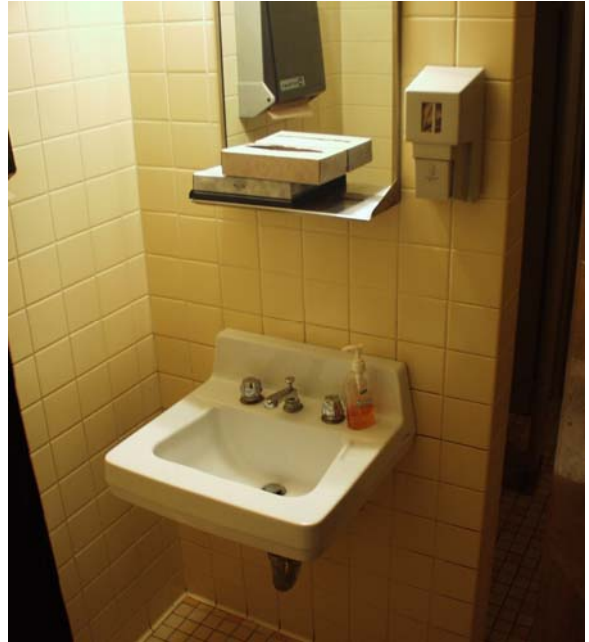
The existing bathrooms do not comply with ADA requirements. The existing fixtures are functional, but cramped.

Section 3 bathroom. ADA compliance is not really practical in this small space.

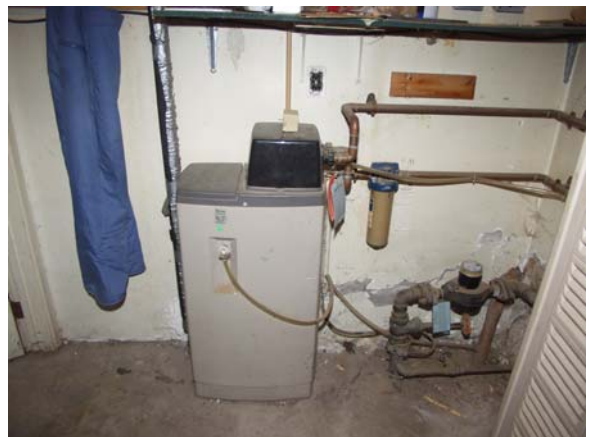
The water softener in the garage mechanical room is not operational. Due to salt intolerance, it might be better not to reconnect the softener unless necessary for a local use.

Water softener. Existing domestic water meter is to the right near the floor.

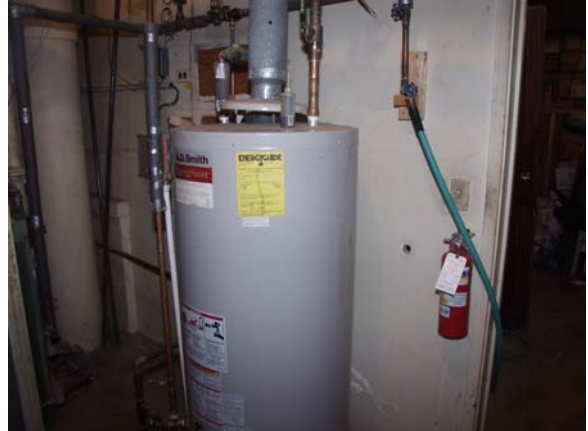
The seventy-five gallon natural gas-fired tank-type water heater has a 75,000 btu/hr input firing rate and is sized for roughly two family service. It is likely adequate for the typically light service in the parish house. However, the system does not provide high temperature water for sanitization and has no standby energy loss limitation features.

Water heater.

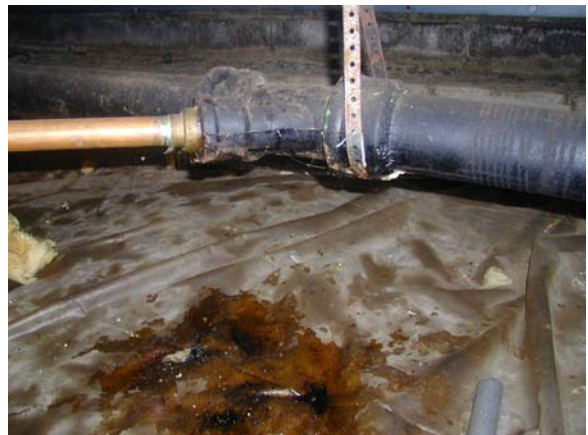
Hub-and-spigot joints on the sanitary lines near the south wall of the crawl space under Section 1 were observed leaking.

Leaking joint.

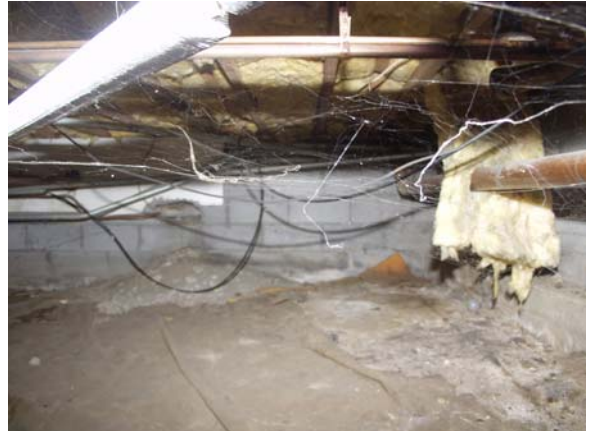
The crawl space is used as a return air plenum. Dust and friable material in the crawl space plenum appear to be ingested by air conditioning units which are open to it. Minimal local air filters will not control small particles. The return air path is not cleanable, and is subject to mold, and other contaminants.

Parish center crawl space.

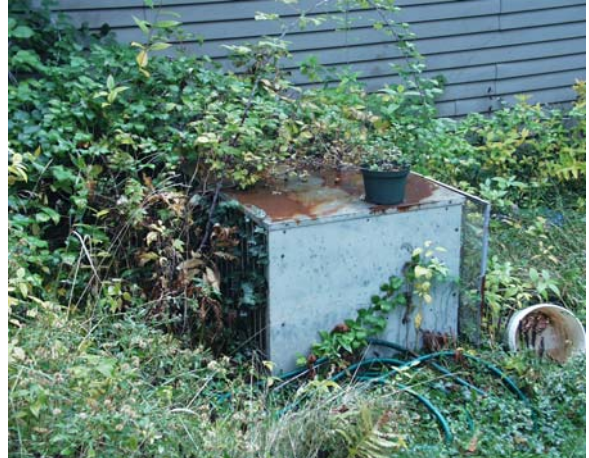
All three parish center main sections were air conditioned in 1964. Presently, however, the air conditioning system serving the assembly space in Section 3 is not operational and may not have operated for fifteen years or so.

*Section 3 air conditioning
condensing unit (not
operational).*

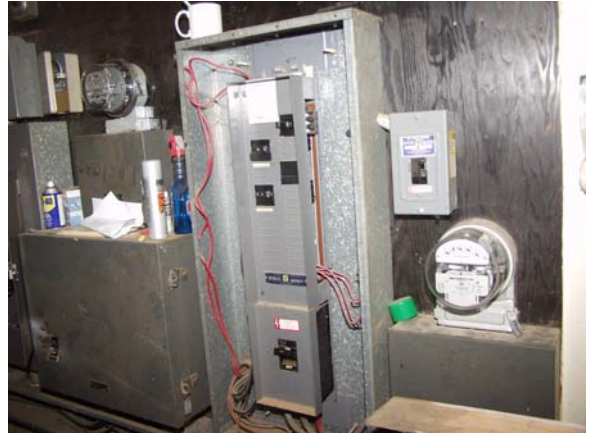
The Parish House is served by two electrical systems. A three-phase system serves air conditioning systems, and a separate single-phase lighting and receptacle system serves everything else. The three phase system is almost out of service due to faulty breakers, which are no longer easily available. It no longer serves any three phase loads. The only load served is the Section 2 air conditioner, which uses only one of the three available power phases.

Three-phase panel.

In the photo above, the right meter to the right of the panel serves the panel itself. The meter to the left serves everything else as a 208 -volt single-phase three-wire panel.

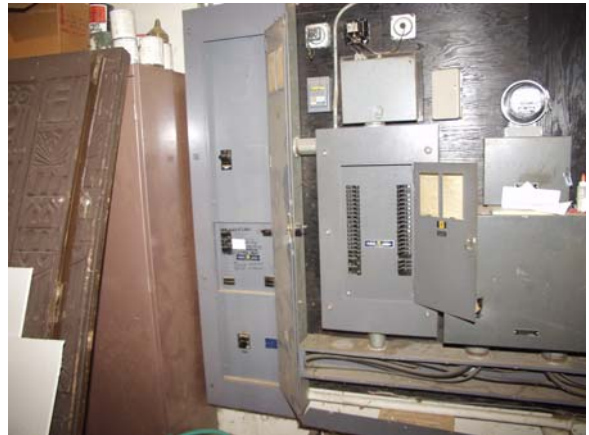
The existing single phase bolt-on panelboards are no longer in popular use. Although significant power is available, spare breaker space is quite limited. Since construction, many small receptacle loads have been added to the Parish House. Additional circuits would be helpful to safely handle the new equipment.

Main distribution panelboard at left, serving three subpanels, one of which is at right..

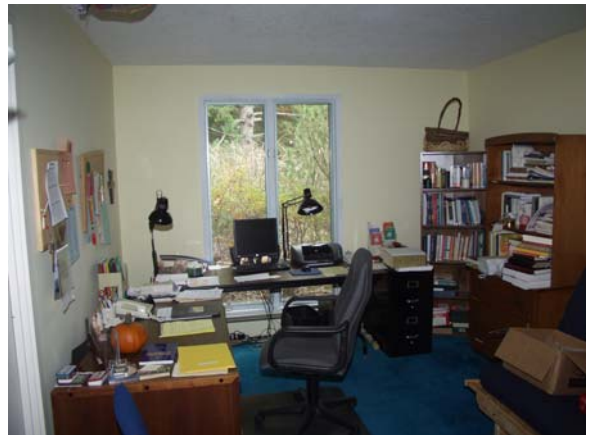
The lighting in office spaces is relatively poor, although functional. The Section 1 offices and small lounge do not have overhead lighting because they were designed for residential use which relies on table lamps or floor lamps. These are not really effective for sustained office occupancy. Lighting on the desk is lumpy and shadowy.

Task lamps compensating for lack of overhead lighting. In 1964, this space was appropriately served by table lamps, but these are not really effective for sustained use.

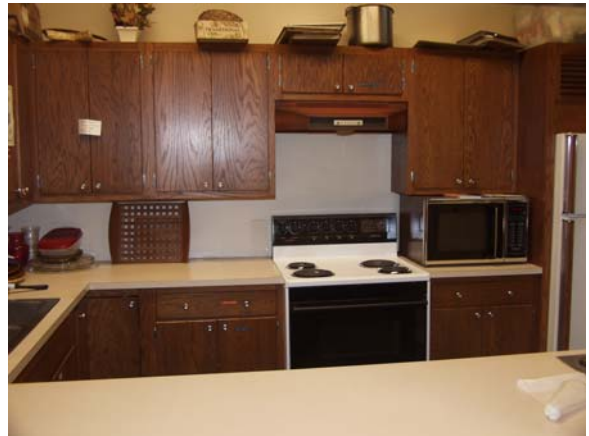
The existing assembly area kitchen shown here is typical of a family single residence kitchen and is not equipped with features essential to commercial kitchens. The exhaust hood over the stove is not vented to the outside or provided with fire suppression. Food preparation space is too small for large volume preparation. No space or equipment is provided for holding food at safe temperatures, or for safe serving practices. Food storage facilities are also minimal, consisting of one residential refrigerator/freezer.

The existing stove is not large enough or powerful enough for commercial size pots.

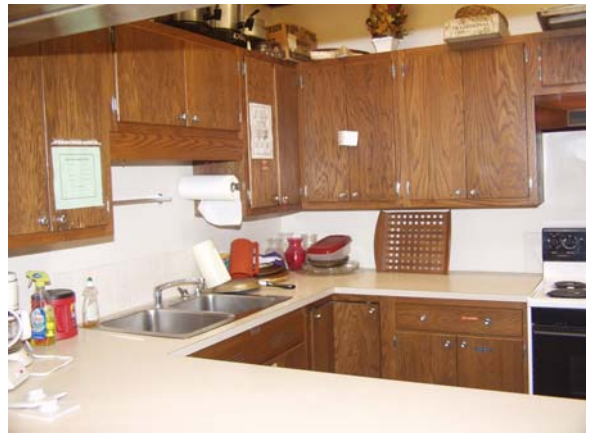
The existing sink is much smaller than the usual three bay sink required to sanitize pots and large sheets.

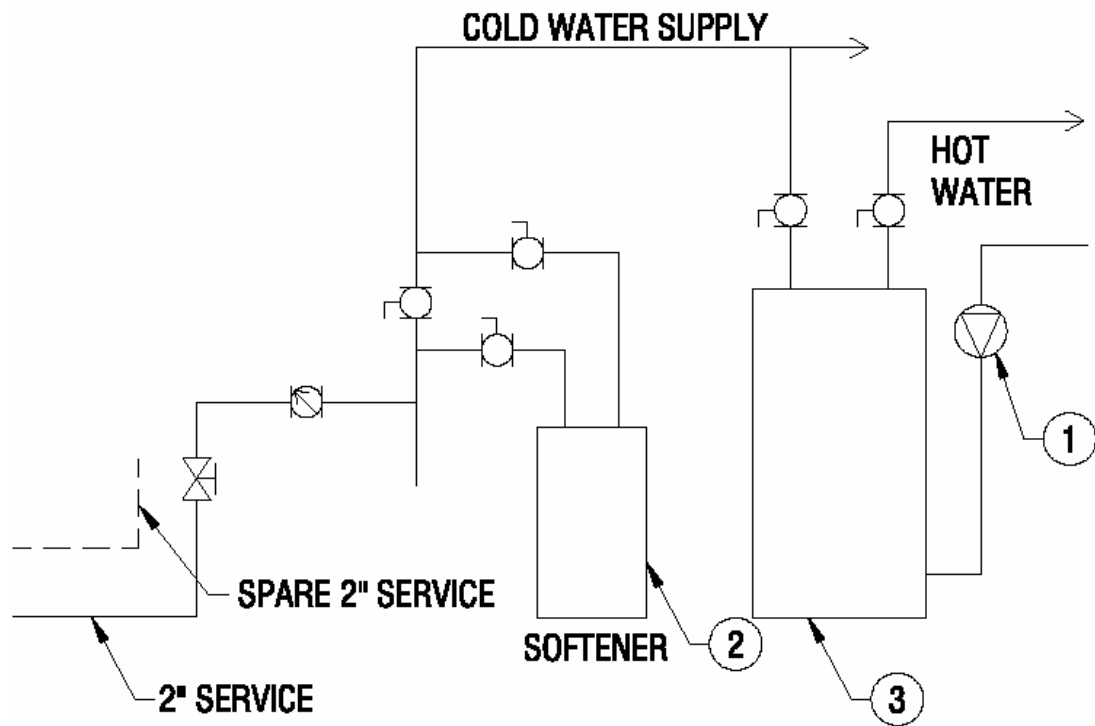
4.2.2 Plumbing Water Distribution

1. Recirculation pump.
2. Softener not operational.
3. 75 Gallon gas fired tank type water heater.

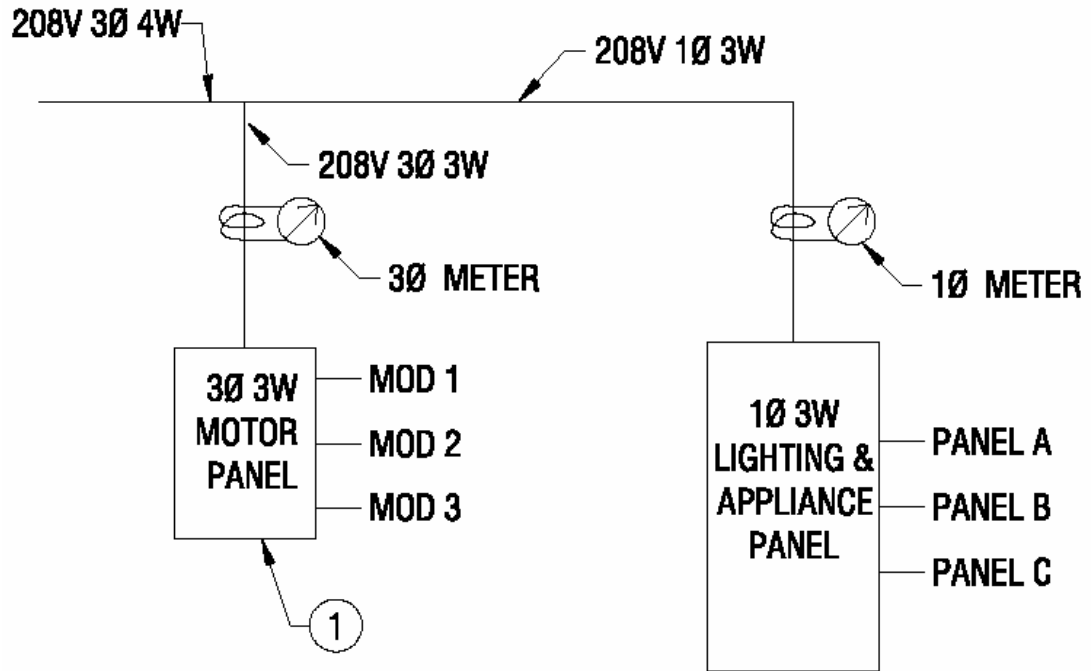
4.2.3 Electrical Distribution

1. Only Section 1 condenser is connected to this panel board. No other loads are still connected.
