Property Condition Report

ST. CATHERINE OF SIENA PARISH CENTER AND CHURCH

302 St. Catherine's Circle
Ithaca, New York

October 31, 2007

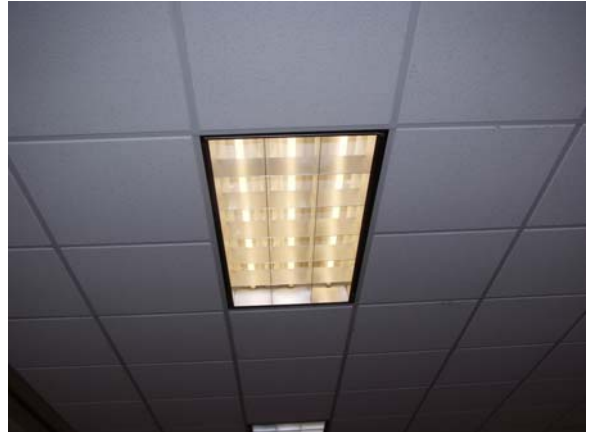
seated at tables. Efficiency is reasonable with high efficiency electronic ballasts. This system works well with traditional computer screens because it tends to limit glare. The fixtures tend to provide a sharp cutoff low on the sidewalls, with no ceiling coverage.

18 cell parabolic lighting fixture, typical of office lighting a few years ago.

Many people find that indirect or partially indirect lighting systems which provide more illumination on sidewalls and ceiling are more comfortable for general use. It is, however, a matter of preference.
